DEPARTMENT OF TRANSPORTATION**DIVISION OF ENGINEERING SERVICES**

Contract #: 04-0120F4Cty: SF/Ala Rte: 80 PM: 13.2/13.9File #: 69.28**WELDING INSPECTION REPORT****Resident Engineer:** Siegenthaler, Peter**Address:** 333 Burma Road**City:** Oakland, CA 94607**Report No:** WIR-016560**Date Inspected:** 27-Aug-2010**Project Name:** SAS Superstructure**OSM Arrival Time:** 1900**Prime Contractor:** American Bridge/Fluor Enterprises, a JV**OSM Departure Time:** 700**Contractor:** Zhenhua Port Machinery Company, Ltd (ZPMC), Changxing Island **Location:** Shanghai, China**CWI Name:** See below**CWI Present:** Yes No**Inspected CWI report:** Yes No N/A**Rod Oven in Use:** Yes No N/A**Electrode to specification:** Yes No N/A**Weld Procedures Followed:** Yes No N/A**Qualified Welders:** Yes No N/A**Verified Joint Fit-up:** Yes No N/A**Approved Drawings:** Yes No N/A**Approved WPS:** Yes No N/A**Delayed / Cancelled:** Yes No N/A**Bridge No:** 34-0006**Component:** Tower and OBG Components**Summary of Items Observed:**

WELDING INSPECTION REPORT

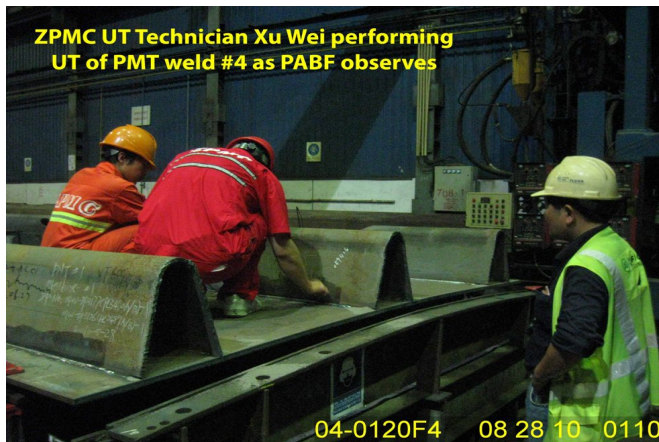
welding of the 3–12mm x 20mm specimens was approximately 0015 hours on 8/28/10 and the finish time was approximately 0034 hours. This QA Inspector randomly verified and documented the welding amperage, voltage, and travel speed during the gas metal arc welding (GMAW) and submerged arc welding (SAW) processes, welds 1 thru 6 at the completion of both the GMAW root pass and SAW cover pass. The welding variables recorded by PABF appeared to comply with WPS-B-T-2342-U1-(U-rib)-5. The welds were visually inspected by PABF and this QA Inspector. PABF informed this QA Inspector that all six welds were acceptable and after random inspection this QA Inspector concurred. This QA inspector randomly witnessed ZPMC ultrasonic testing (UT) inspector, identified as Xu Wei, perform UT on each of the 500 mm test welds for depth of penetration and conformance. See photo below of UT in progress. This QA Inspector selected fifteen designated locations for macroetch sampling per contract requirements. Each macroetch sample location was stamped by ZPMC personnel with the number 3177, a number 6, chosen randomly by this QA Inspector as a verification mark, and an individual progressive macroetch identifying number for each macroetch sample. See photos below. After removal from each of the weld test specimens, polishing, and acid etching of the selected end, the macroetch samples were evaluated using a 7X optical magnifier and accepted by PABF and this QA Inspector.

All fifteen sample macroetch samples appeared to meet requirements and were noted to appear acceptable. See Caltrans U-ribs PMT Inspection Sheet, ZPMC Production Monitoring Test Plate Inspection Report, and Caltrans Macro Etch Log - all dated 8/28/2010 for additional information.
